Roland Water Tower Park
Maryland Historic Trust
Historic Preservation Easement Program
Change/Alteration Request Application
July 28, 2021 Support Materials

TREE ASSESSMENT & RECOMMENDATIONS

ROLAND WATER TOWER PARK
4210 Roland Avenue
Baltimore, MD 21210

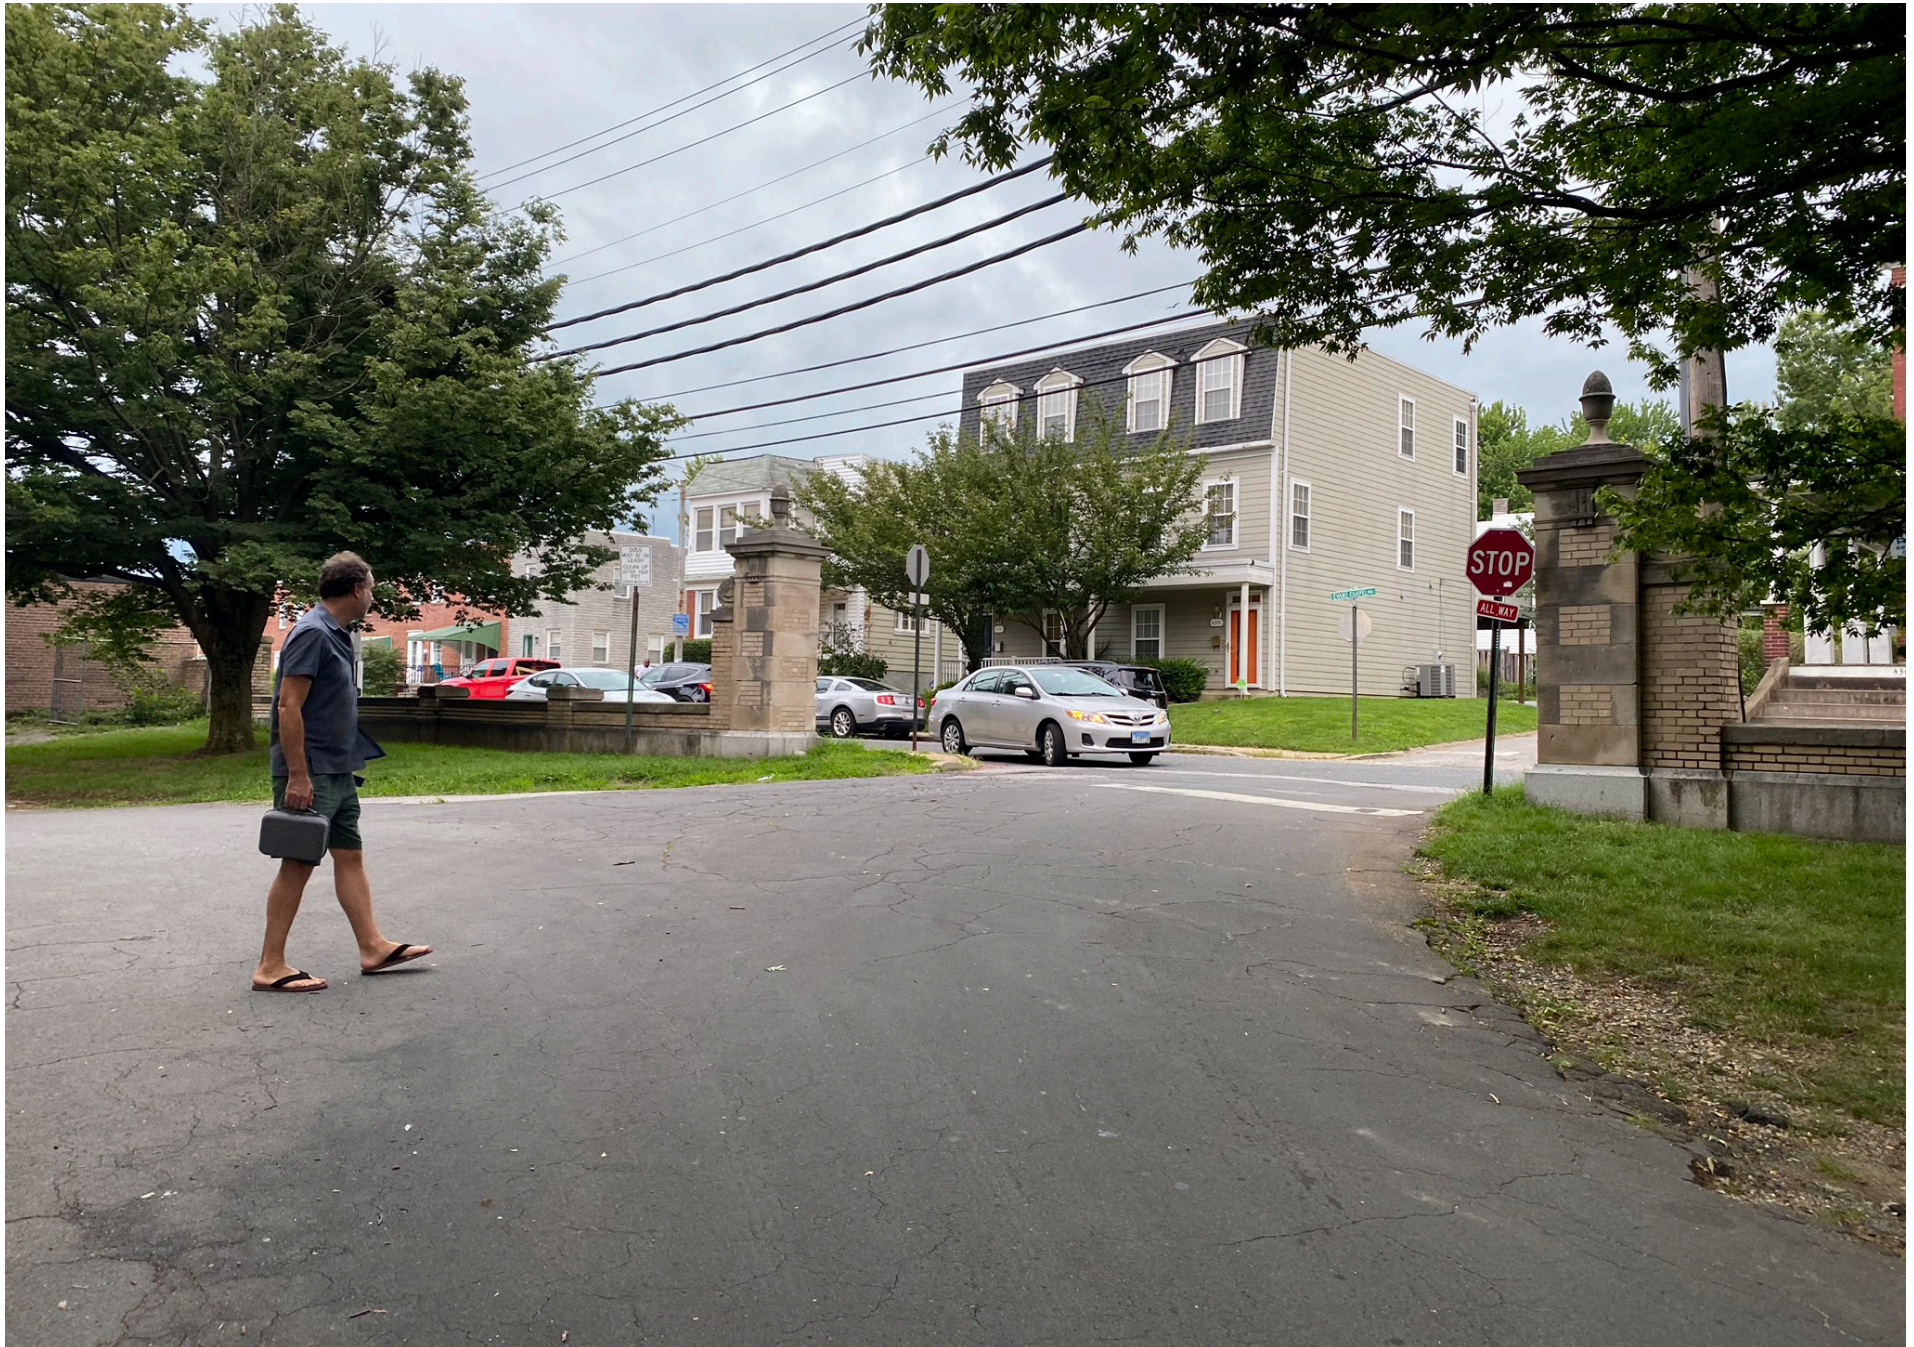
Roadway Condition

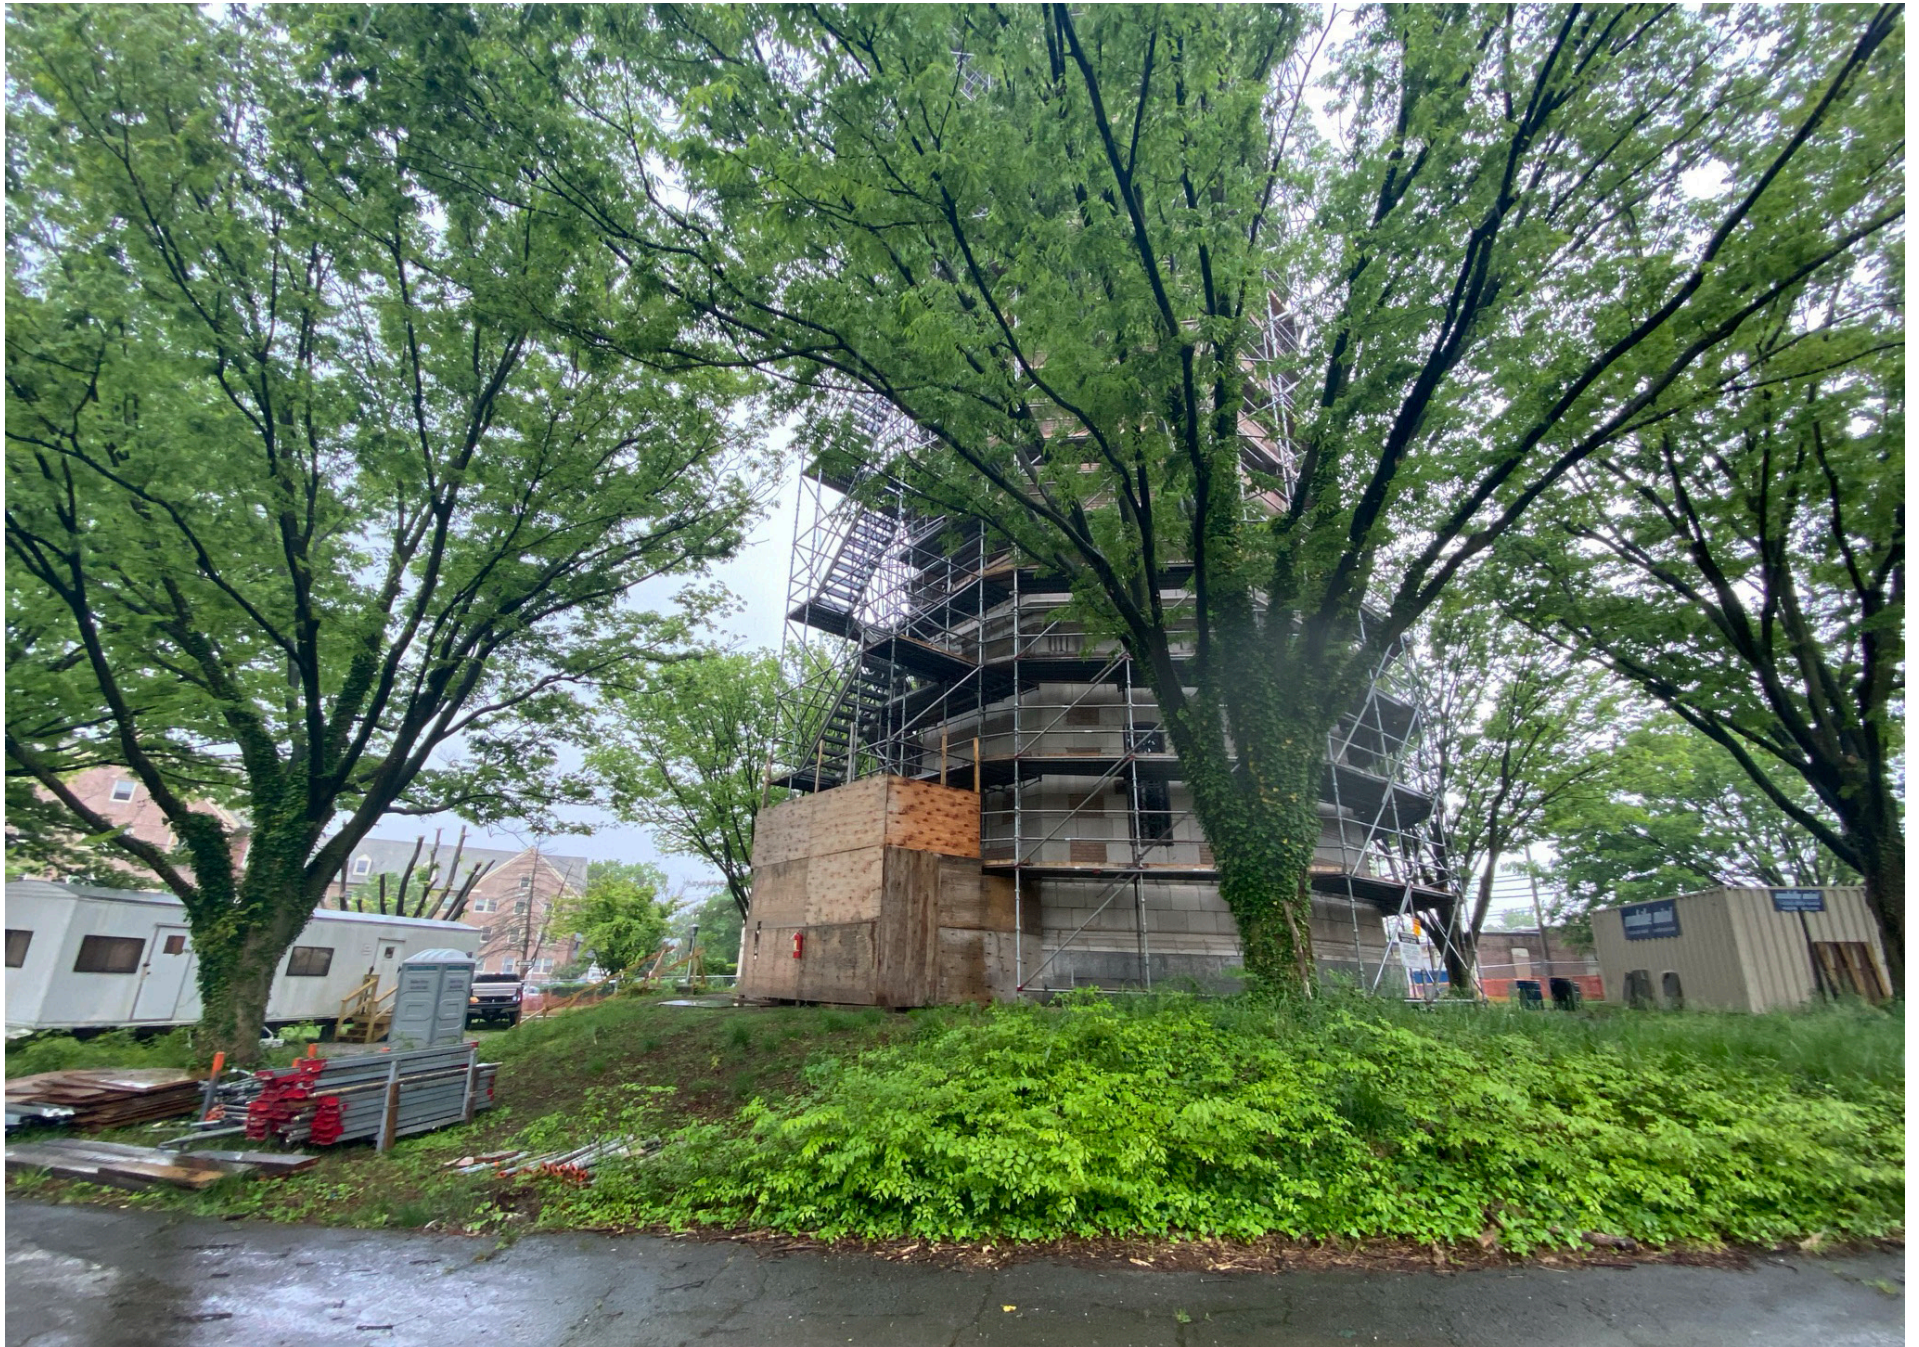
Zelkovas at Site Interior - impacted by current and planned construction (6 total)

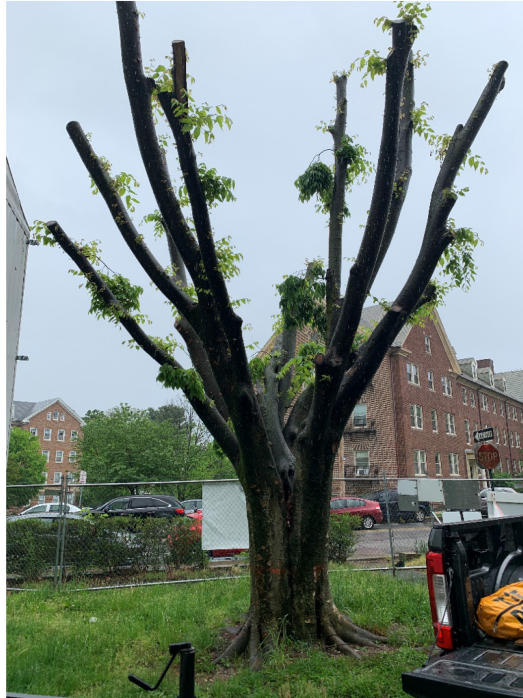
Figure 2. Specimen #1 located on the southeast corner of the site.

Specimen 1: Zelkova Serrata

DBH: 28.5"

Condition: Poor

Remove. Grind and remove stump if grading and path network of future park requires a flush area.

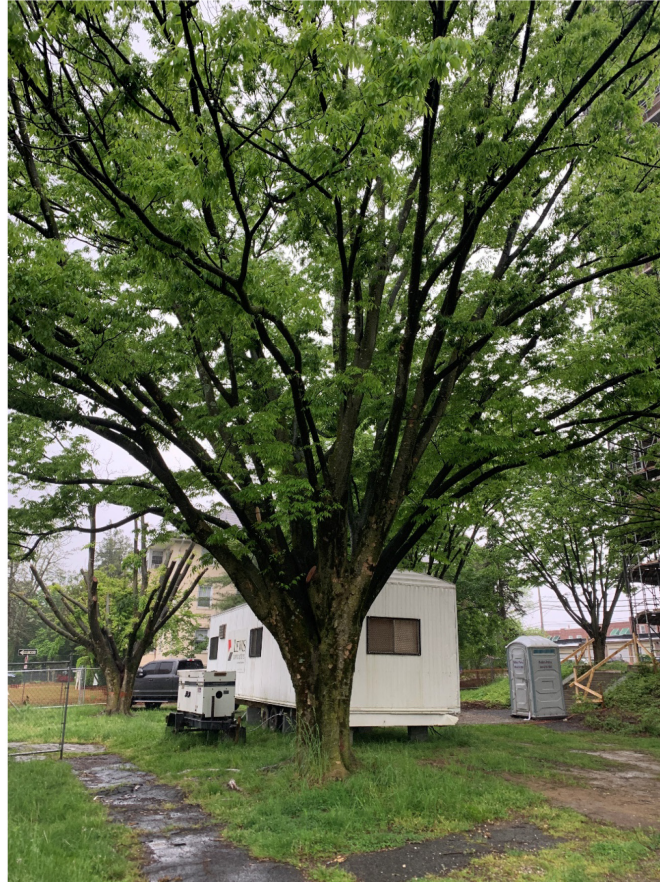
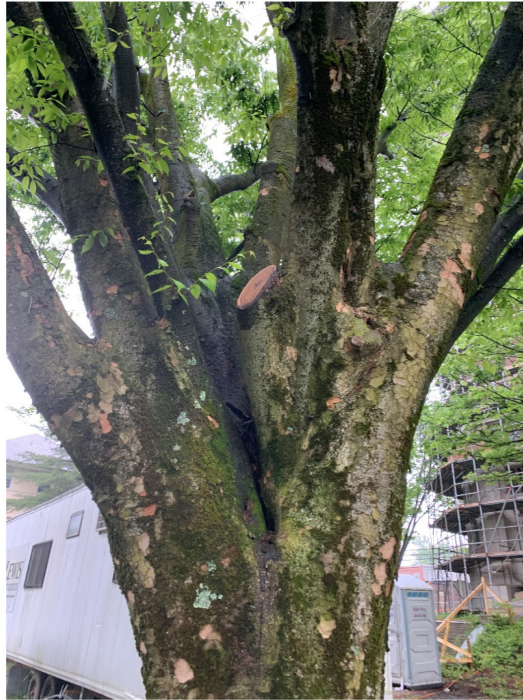
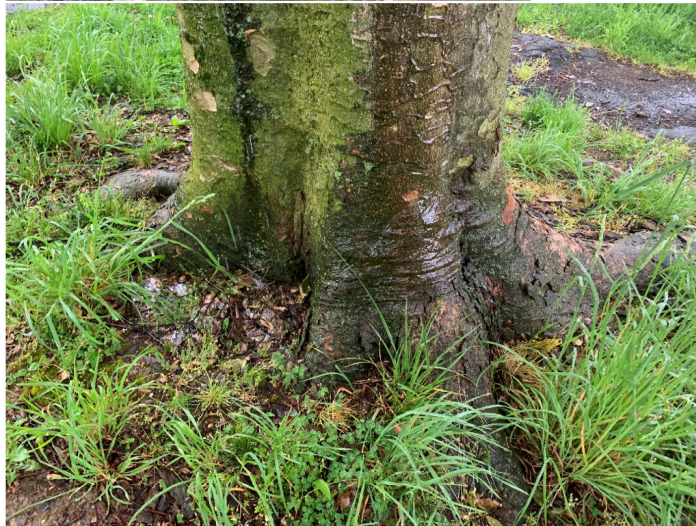
Figure 3a-3c. Specimen #2 located on the northeast corner of the site.

Specimen 2: Zelkova Serrata

DBH: 32.48"

Condition: Good

Symmetrical and full canopy, with even branching of small and large limbs. Some included bark at base of crown as is typical of species. Recently pruned. No apparent pests or girdling. Some previous injury apparent but no visible rot or major damage.

Preserve. Specify tree protection fencing during construction based on caliper-derived critical root zone of 15" radius per caliper inch (CRZ). Do not permit heavy equipment or staging within CRZ. Excavation within CRZ only with prior approval by Landscape Architect. Monitor for signs of damage from contractor's equipment on-site.

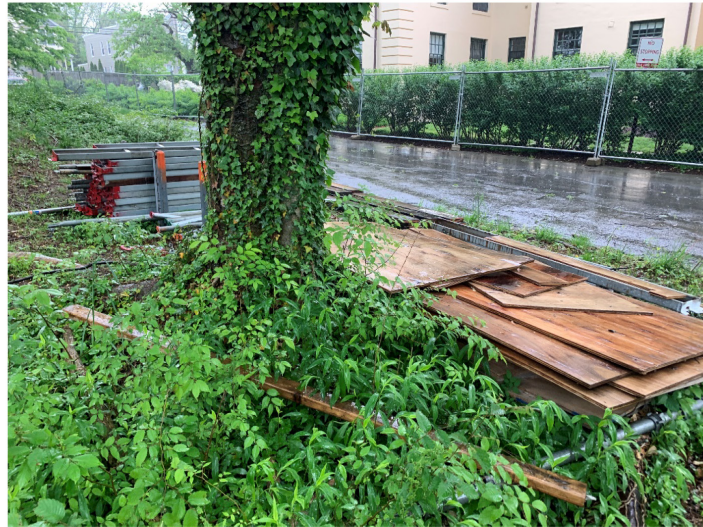
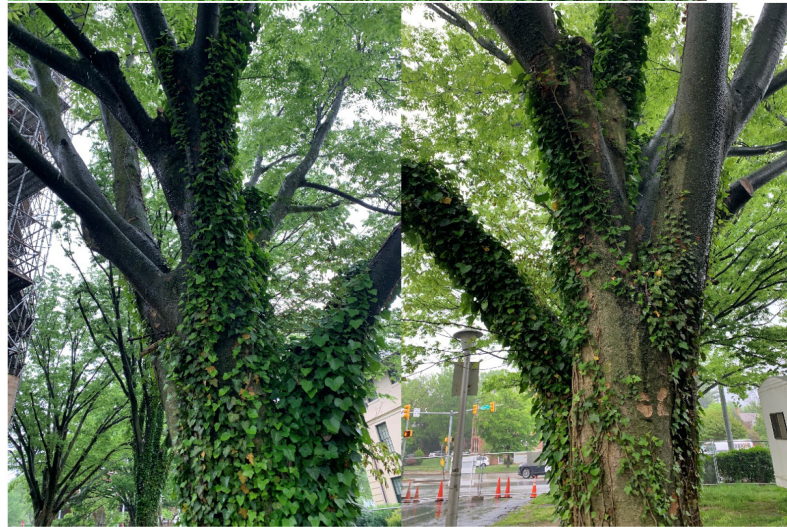
Figure 4a-4c. Specimen #3 located on the north central portion of site.

Specimen 3: Zelkova Serrata

Condition: Poor

Partial canopy, estimated 40% missing, likely due to deferred maintenance and shading out of canopy; and recent pruning visible. Hedera helix (English ivy) growth on trunk likely detrimental to this trees overall health, and made good inspection of trunk impossible. Invasive species and contractor staging on root flare detrimental to tree health.

Remove and mitigate off site if required. Grind and remove stump if grading and path network of future park requires a flush area.

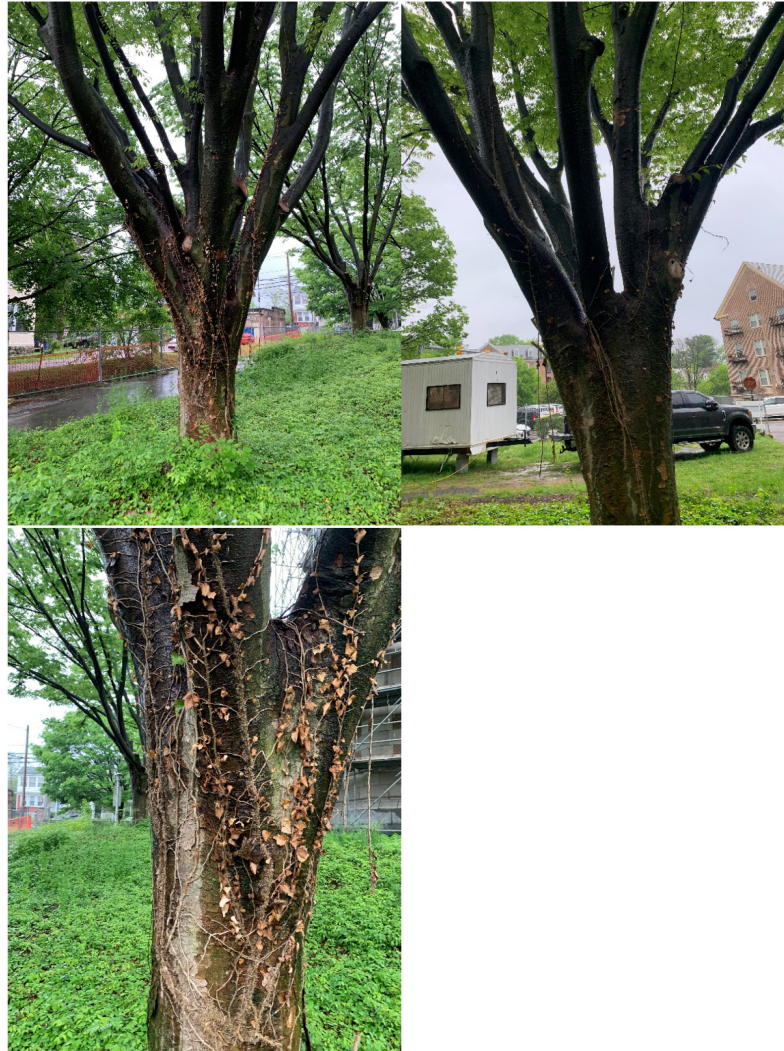
Figure 5a-5c. Specimen #4 located on the south central berm on the site

Specimen 4: Zelkova Serrata

Condition: Poor

Partial canopy, estimated 40% missing, likely due to deferred maintenance and shading out of canopy; and recent pruning visible. Previous Hedera helix (English ivy) growth on trunk likely detrimental to this tree's overall health. Invasive species and contractor staging on root flare detrimental to tree health as well.

Remove and mitigate off site if required. Grind and remove stump if grading and path network of future park requires a flush area.

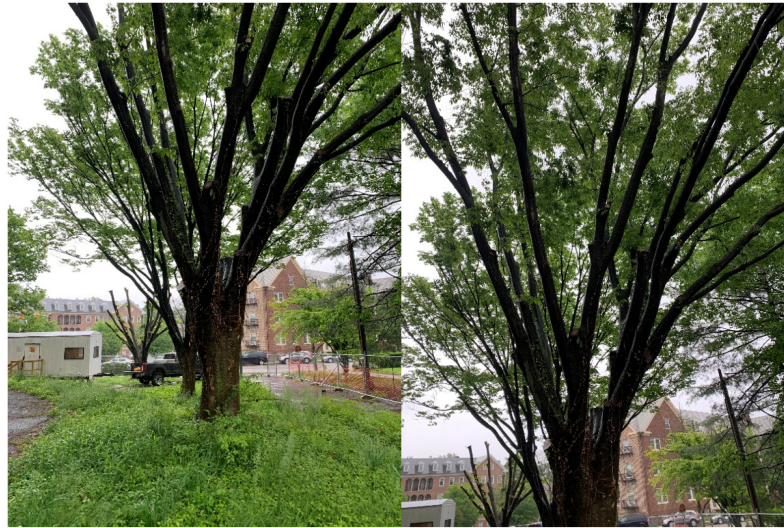
Figure 6a-6c. Specimen #5 located on the south central berm on the site

Specimen 5: Zelkova Serrata

Condition: Poor

Partial canopy, estimated 40-60% missing, likely due to deferred maintenance and shading out of canopy; and recent pruning visible. Invasive species on root flare detrimental to tree health as well.

Remove and mitigate off site if required. Grind and remove stump if grading and path network of future park requires a flush area.

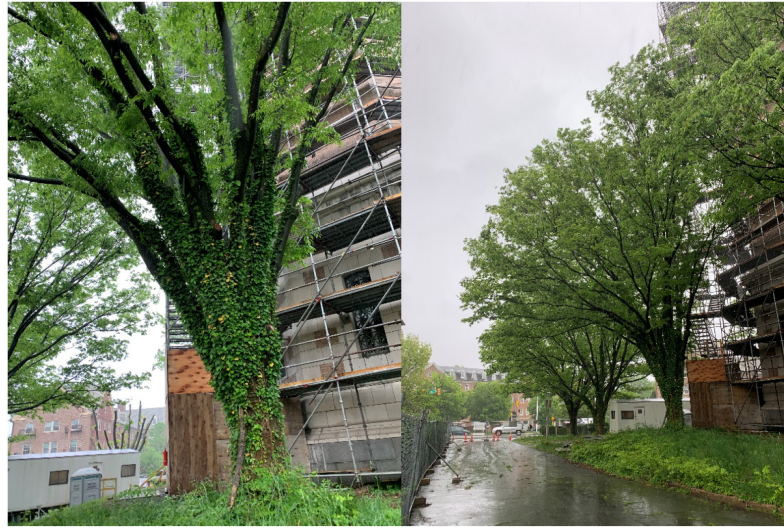
Figure 7a-7b. Specimen #6 located on the north central berm on the site

Specimen 6: Zelkova Serrata

Condition: Fair

Partial canopy, estimated 40% missing, likely due to deferred maintenance and shading out of canopy; and recent pruning visible. Invasive species on root flare detrimental to tree health as well. Hedera helix invasive species detrimental to overall health.

Monitor – if design calls for removal, follow other removal recommendations herein for living removals.

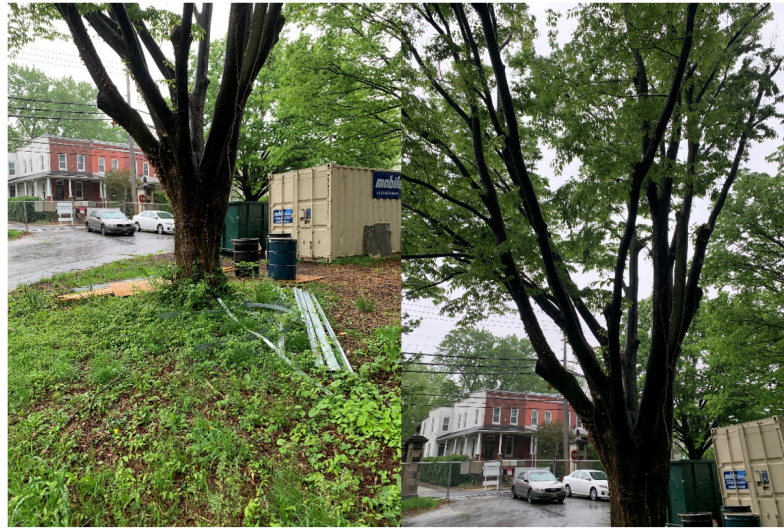
Figure 8a-8b. Specimen #7 located on the southwest berm on the site

Specimen 7: Zelkova Serrata

Condition: Fair

Partial canopy, estimated 40% missing, likely due to deferred maintenance and shading out of canopy; and recent pruning visible. Invasive species on root flare detrimental to tree health as well. Hedera helix invasive species detrimental to overall health. Staging of contractor materials at rootplate potentially long term detriment to tree health.

Monitor – if design calls for removal, follow other removal recommendations herein for living removals.

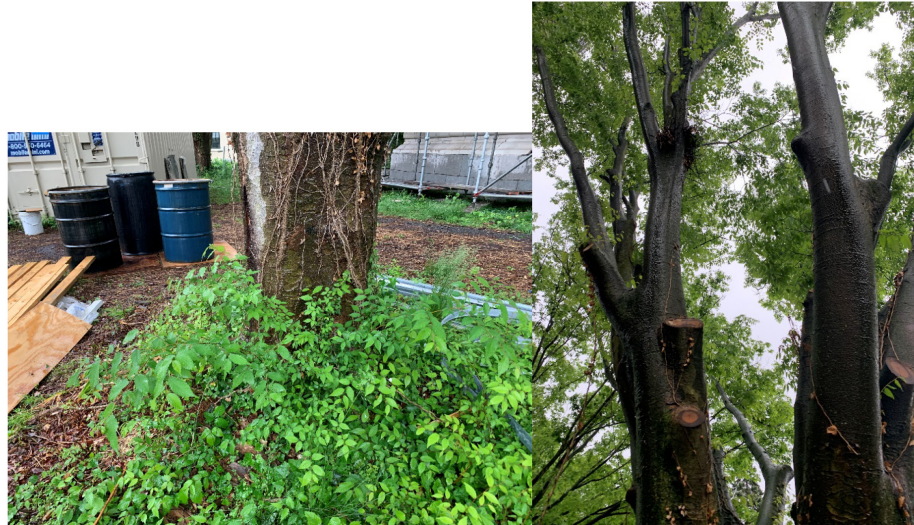
Figure 9a-9b. Specimen #8 located on the northwest berm on the site

Specimen 8: Zelkova Serrata

Condition: Poor

Partial canopy, estimated 50% missing, likely due to deferred maintenance and shading out of canopy; and recent pruning visible. Invasive species on root flare detrimental to tree health as well. Hedera helix invasive species detrimental to overall health. Staging of contractor materials at rootplate potentially long term detriment to tree health.

Remove and mitigate off site if required. Grind and remove stump if grading and path network of future park requires a flush area.

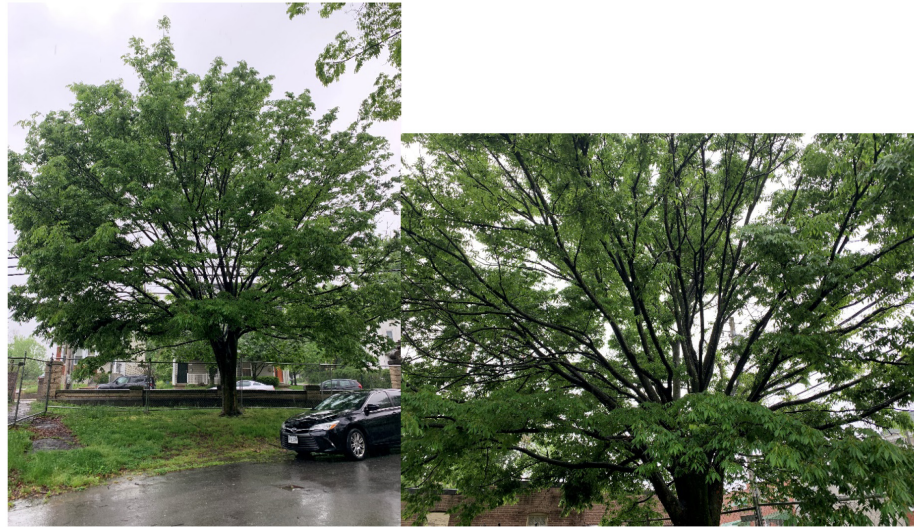
Figure 10a-10b. Specimen #9 located on the southwest portion of the site.

Specimen 9: Zelkova Serrata

Condition: Good

Well rounded canopy with some dead wood. Estimated 10-20% missing, likely due to deferred maintenance. Some girdling of roots observed.

Preserve. Specify tree protection fencing during construction based on caliper-derived critical root zone of 15" radius per caliper inch (CRZ). Do not permit heavy equipment or staging within CRZ. Excavation within CRZ only with prior approval by Landscape Architect. Monitor for signs of damage from contractor's equipment on-site.

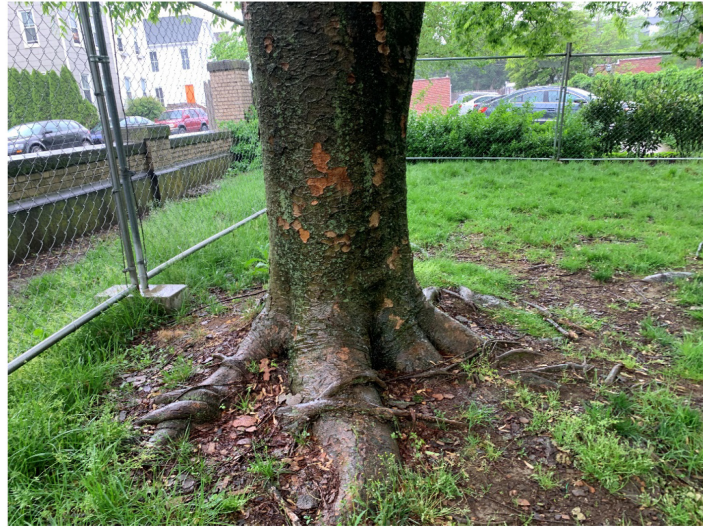
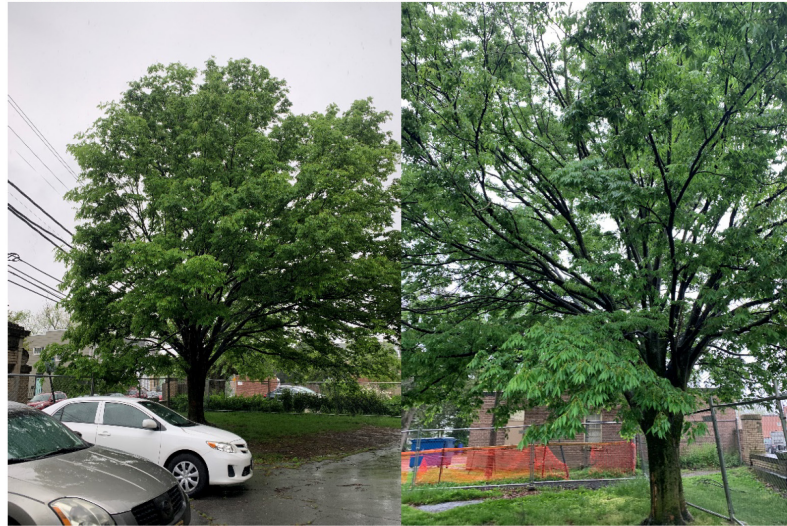
Figure 11a-11c. Specimen #10 located on the northwest portion of site.

Specimen 10: Zelkova Serrata

Condition: Good

Slightly asymmetrical canopy likely due to pruning due to adjacent overhead wires. Estimated 20% missing. Some girdling of roots observed.

Preserve. Specify tree protection fencing during construction based on caliper-derived critical root zone of 15" radius per caliper inch (CRZ). Do not permit heavy equipment or staging within CRZ. Excavation within CRZ only with prior approval by Landscape Architect. Monitor for signs of damage from contractor's equipment on-site.
